# MTT Locates lost reamer assembly, enabling recovery and protecting project value.

USA, North Carolina | HDD Highway Crossing | 42" reamed bore

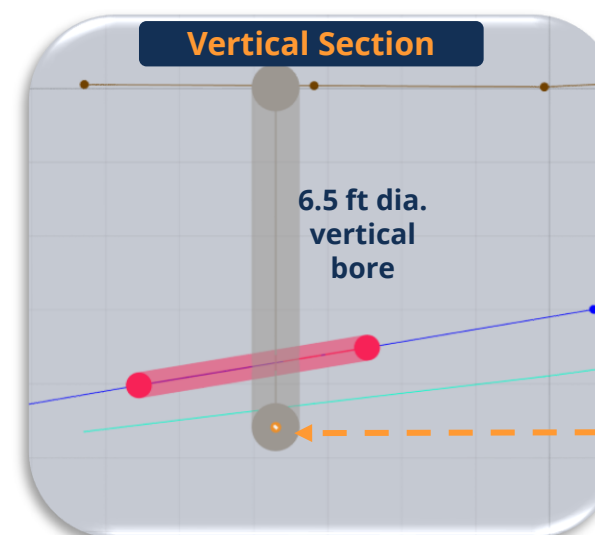
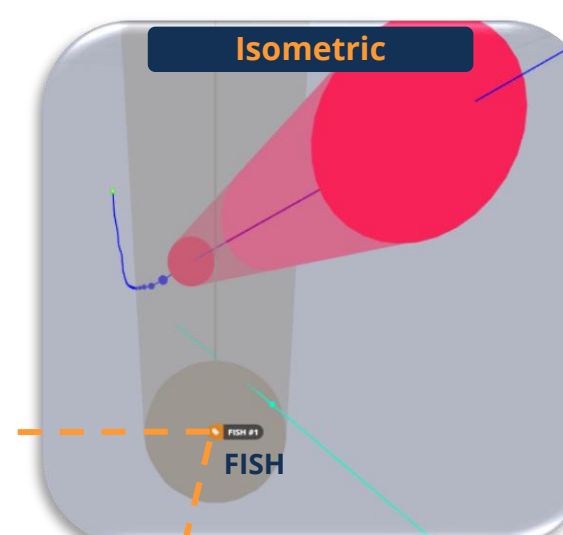
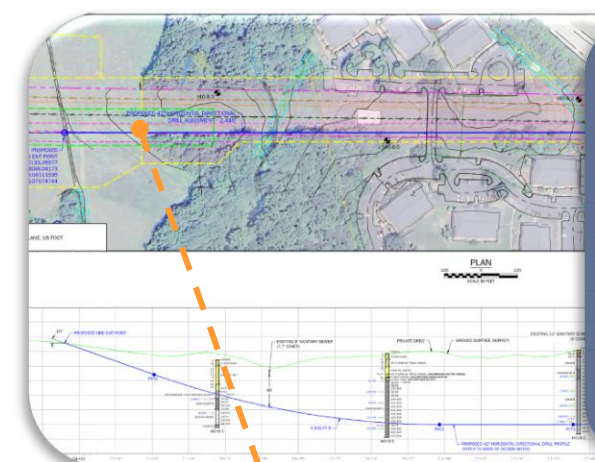
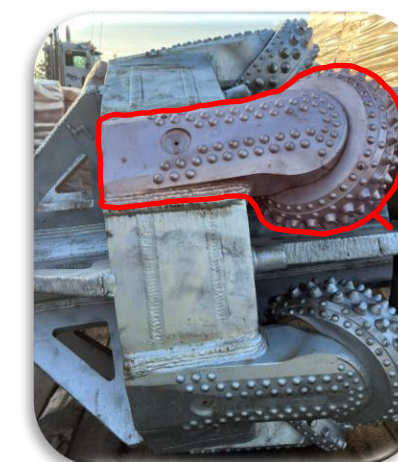
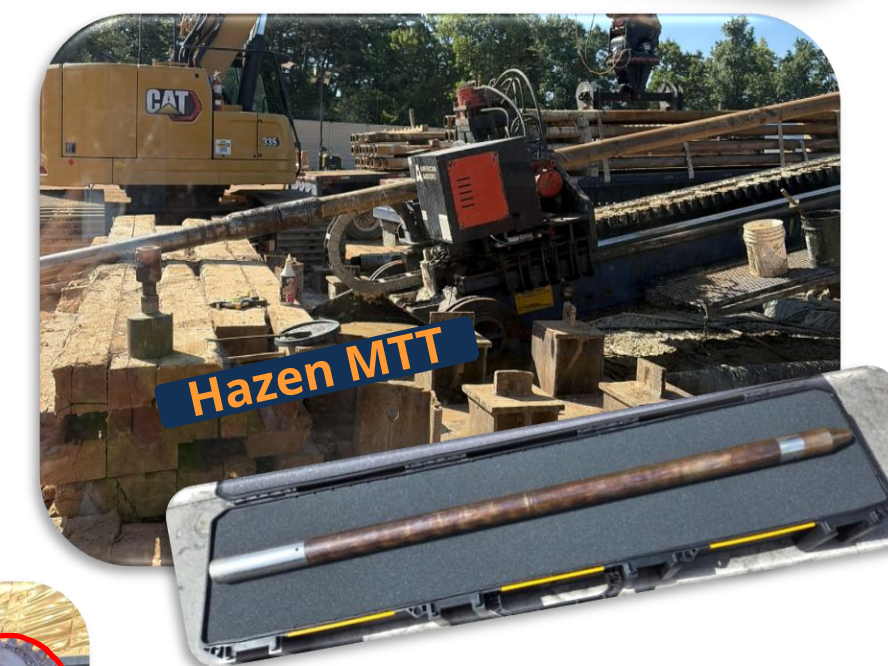
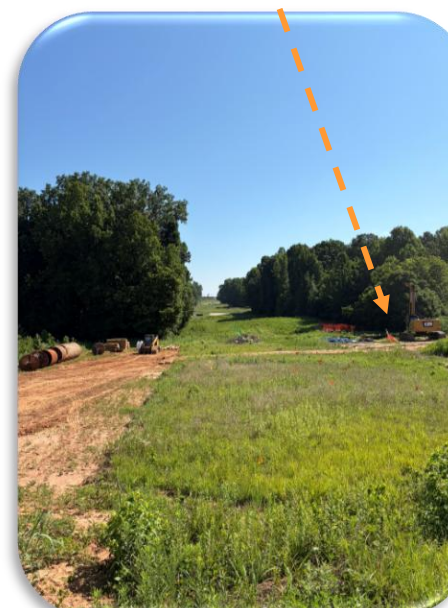
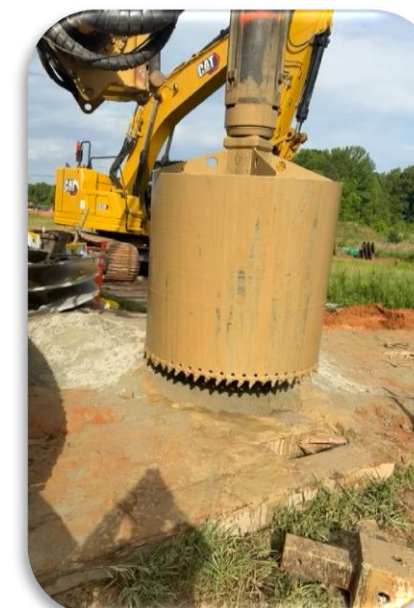
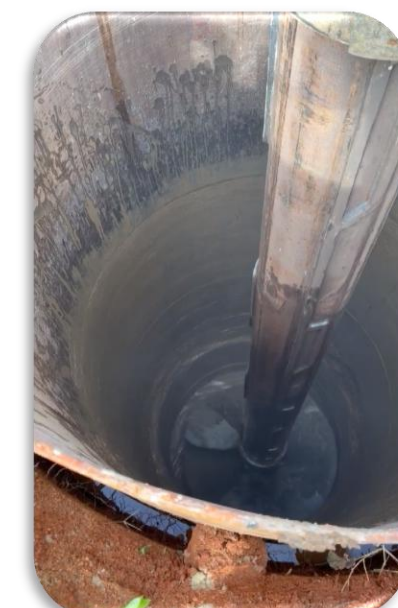
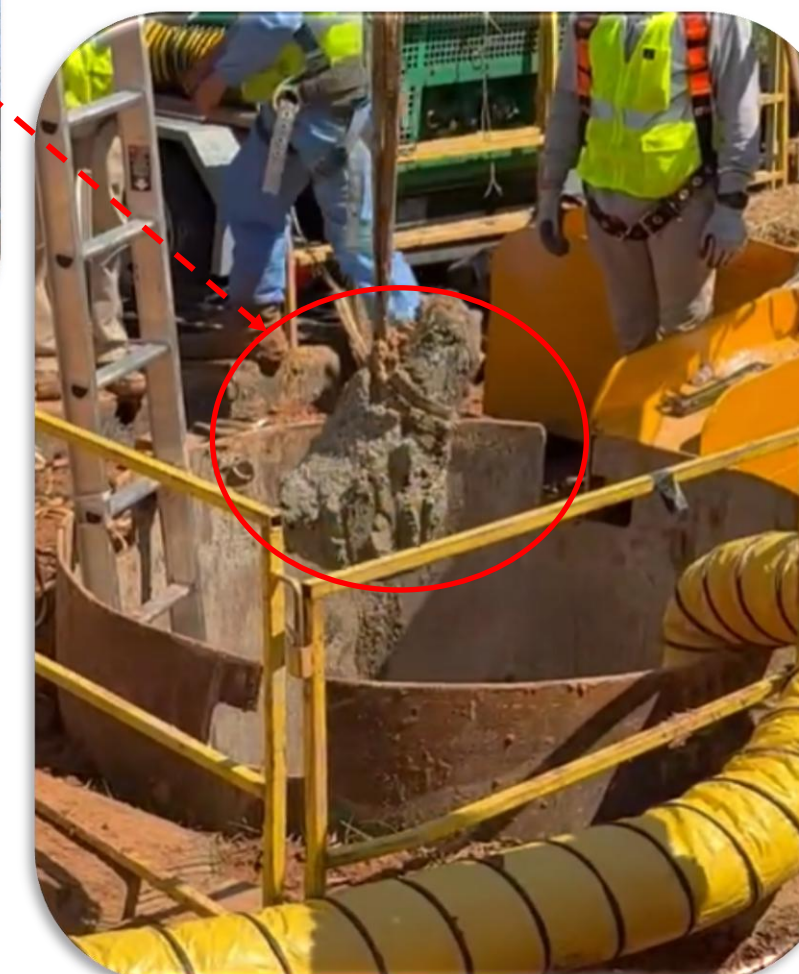
Hazen Bedrock Visualizer

The first MTT run identified a strong magnetic anomaly at 222 ft that was consistent with the lost reamer components.

A focused confirmation run determined that the sensor passed approximately 2.3 ft from the target, with the assembly positioned below and to the left of the bore path at a reported  $-126^\circ$  tool face.

Using the MTT-derived location, the contractor drilled a vertical access hole from surface and successfully recovered the lost components.
